Town of Andover, Massachusetts

Fish Brook Initiative Final Report

June 2006

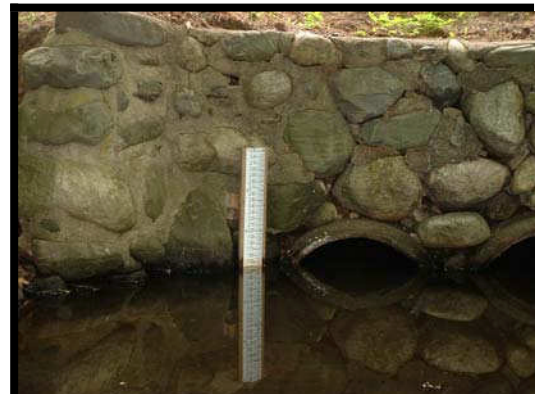
The committee installed a staff gauge at each stream gauging station (shown photo below). Staff gauges are used simply to record the level or elevation of the stream at any point in time. To determine flow rate it is necessary to measure the actual stream flow on several occasions, and then develop a correlation between staff gauge measurement and flow rate. With the correlation established the stream flow rate could be reliably estimated using only the staff gauge reading.

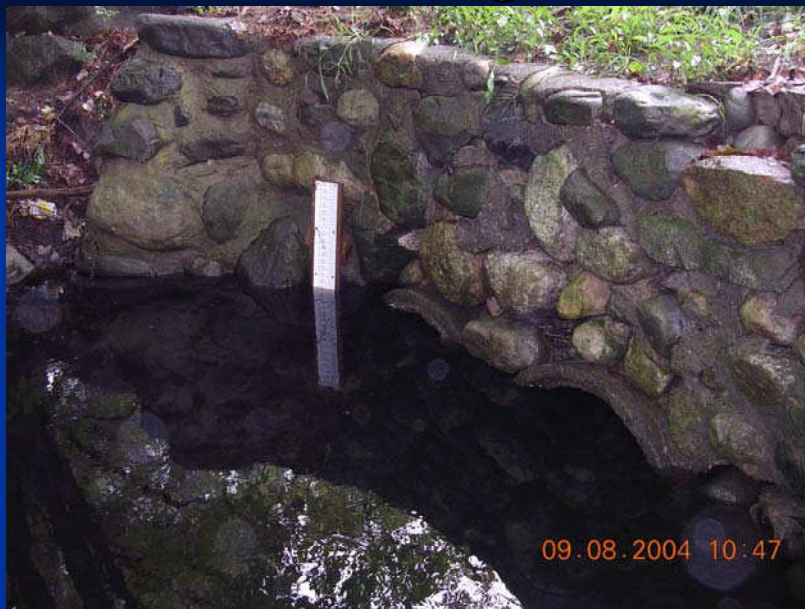
Staff Gauges
